# CHARLOTTEBURG DAM

## PHASE I INSPECTION REPORT NATIONAL DAM SAFETY PROGRAM

NJ00316

JUNE 1978

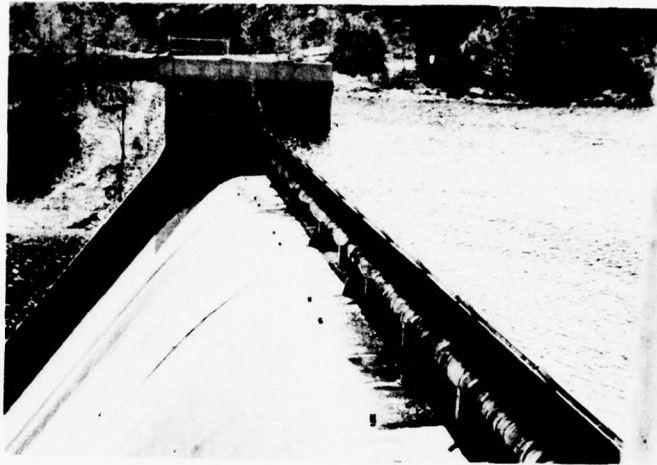
Photo 1 - View of spillway and bascule crest gate  
looking toward right abutment

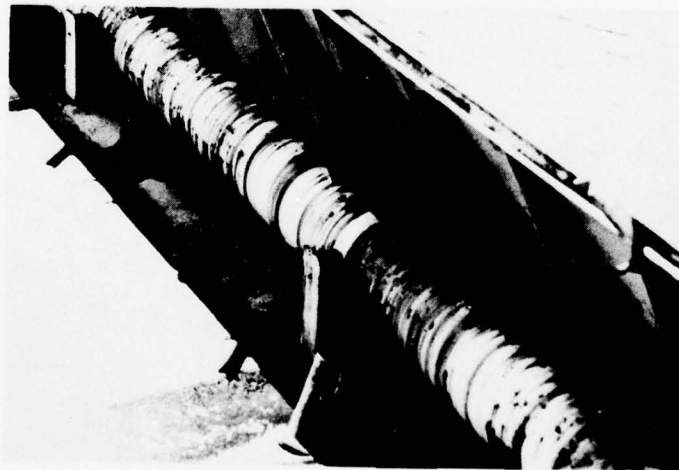
The bascule gate shows minor surface corrosion occurring over approximately 10 percent of the visible surface area. At the next available opportunity the entire gate should receive a coat of protective paint.

The bascule gate seals in the closed position leak a considerable amount of water on the right half of the spillway. This condition, while not objectionable in the summer, could lead to excessive ice build-up on the ogee and gate in a severe winter which would exceed the ability of the heaters to control the problem. This would reduce the spillway capacity. This leakage would make dewatering of the stilling basin difficult. The cause for leakage should be ascertained and corrective measures taken.

Photo 2 - Close-up of bascule crest gate in fully  
closed position

- (4) The bascule gate should be repainted. The gate's operating piston rod seal should be repacked to prevent loss of hydraulic fluid. The scales on the right side of the gate should be checked and repaired to eliminate large volume leakage water when the gate is closed.

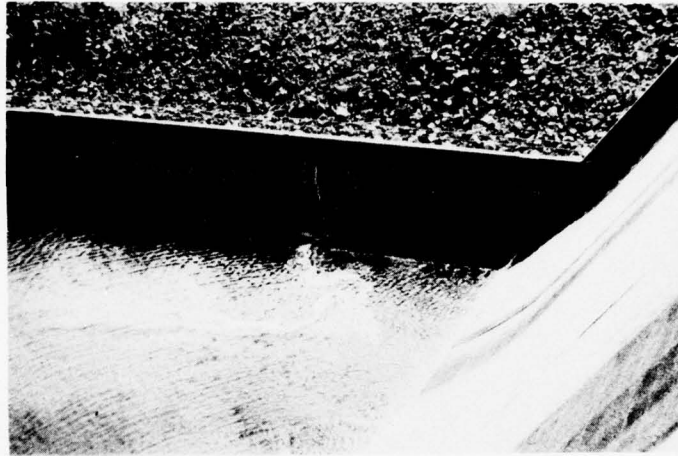
Photo 3 - Stilling basin and right stilling basin wall

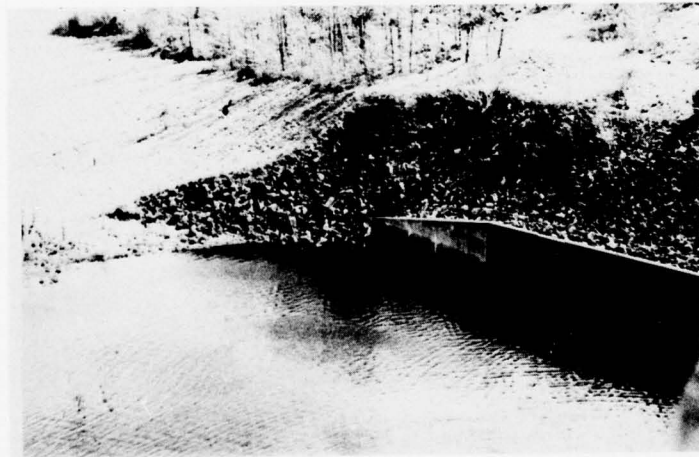
Photo 4 - Downstream end of right stilling basin wall;  
end sill and baffle blocks are submerged by  
normal tailwater

- (2) Repair lift joint in overflow monolith No. 9 at elevation 685 to 690  $\pm$ .
- (3) Dewater stilling basin and inspect floor, chute blocks and end sill for erosion of concrete surfaces. Repairs, if required, should be initiated in calendar year 1979.

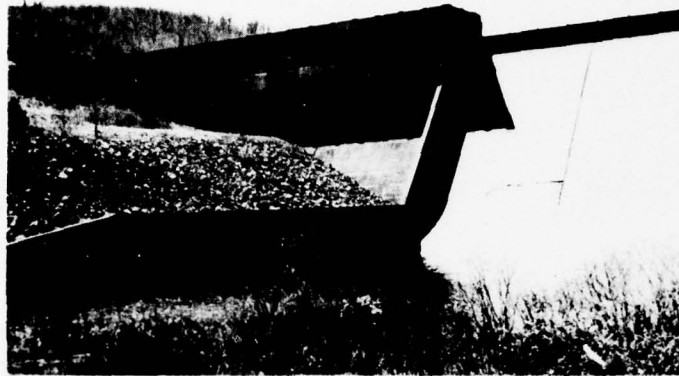
Photo 5 - Spillway, right abutment and right stilling basin retaining wall. Note wet spot on downstream face of non-overflow monoliths indicating poor lift joint

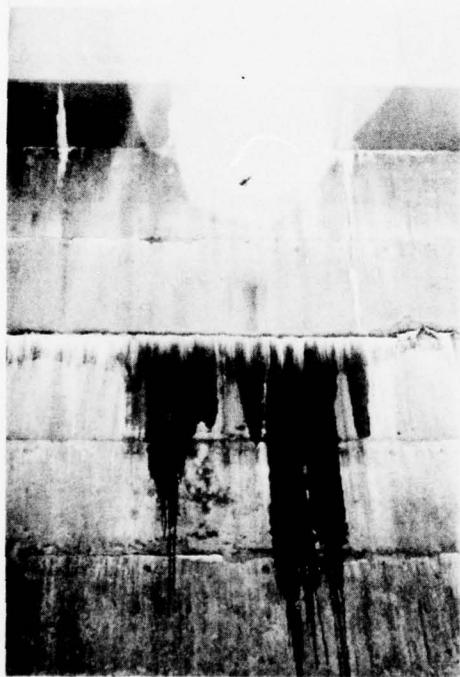
In Monolith 11, there appears to be a defective horizontal lift joint which exhibits through-the-dam leakage for about a 10-ft. width. This location is in the right bulkhead (non-overflow) section at approximately elevation 738. The low head on this joint at the time of inspection, (approx. 3 to 5 feet) indicates that the defect must be fairly wide spread in order to leak right through the whole thickness of the concrete, which is 15-ft. thick at this level.

Photo 6 - Close-up of wet spot on monolith 11 indicating leakage through bad horizontal lift joint

- (1) Investigate through dam leakage in horizontal lift joint in non-overflow monolith No. 11 and formulate plan for repair. Repair of this joint should be initiated in calendar year 1979.

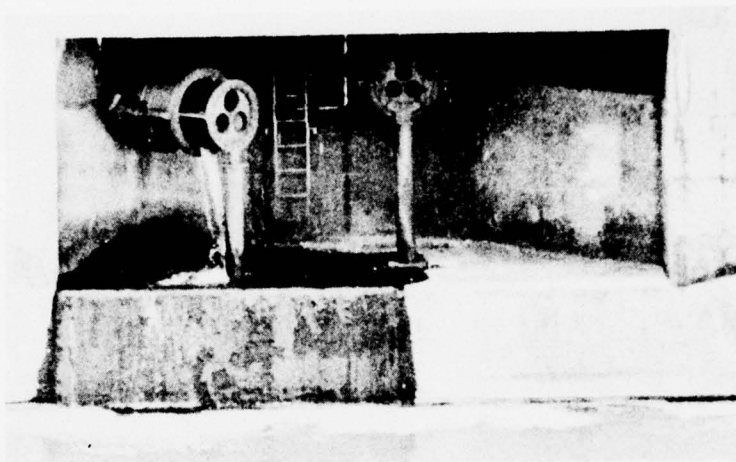
The outlet hollow cone valve for the 48-inch by-pass line located on the left side of the stilling basin had a crack in the operating mechanism housing. As a result, if lubricating oil were placed in the drip feed reservoir, it would run out through the housing. The leak in the housing should be repaired so that proper lubrication can be provided for the operating mechanism.

Photo 7 - Left stilling basin wall showing recess for 30-inch diameter hollow cone valve from 48-inch diameter by-pass line (left) and 24-inch diameter hollow cone valve for draining of 54-inch diameter raw water line (right)

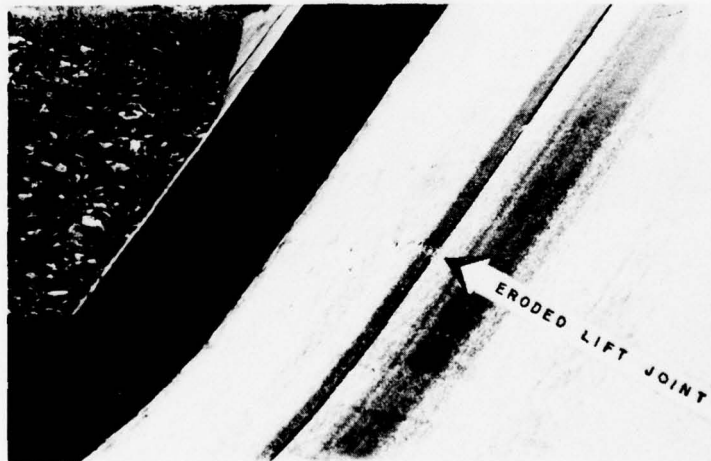
Photo 10 - Spillway looking toward right abutment  
showing poor lift joint in monolith 9

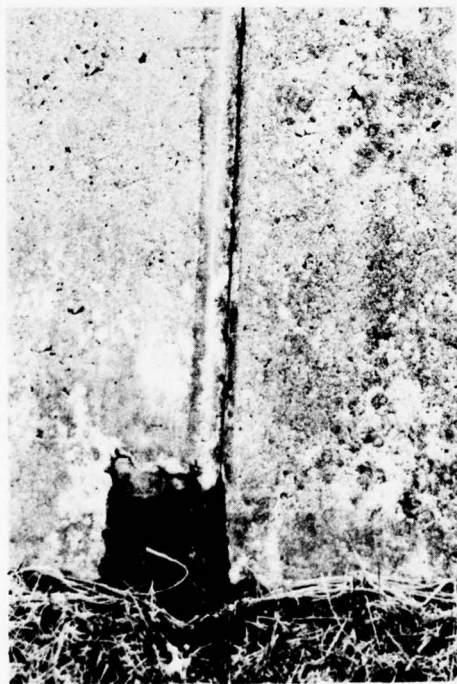
Photo 12 - River Wall - Leaking  
vertical monolith joint  
at base of monolith

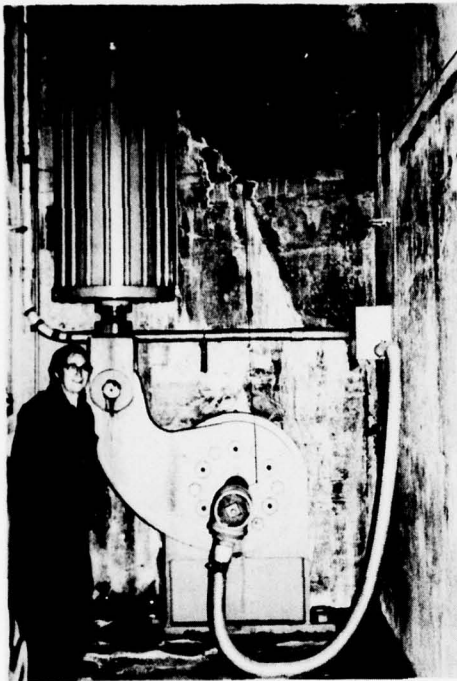
Prior to this inspection, the hydraulic cylinder on the east end of the bascule gate had developed a small leak at the piston rod seal. Operation of the gate was not affected, and the leak eventually stopped. The local operator stated that Allis Chalmers, the original manufacturer of the gate, was scheduled to replace the piston rod seal during July 1978 (when the reservoir level is down below the concrete crest).

Photo 13 - Spillway bascule gate  
actuating cylinder on  
left abutment

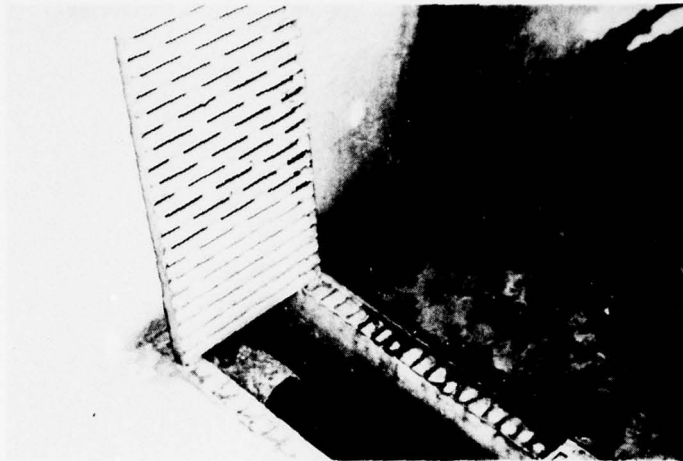
Photo 19 - Lower Inspection Gallery - Typical joint drain;  
looking upstream at joint (to left of drain)

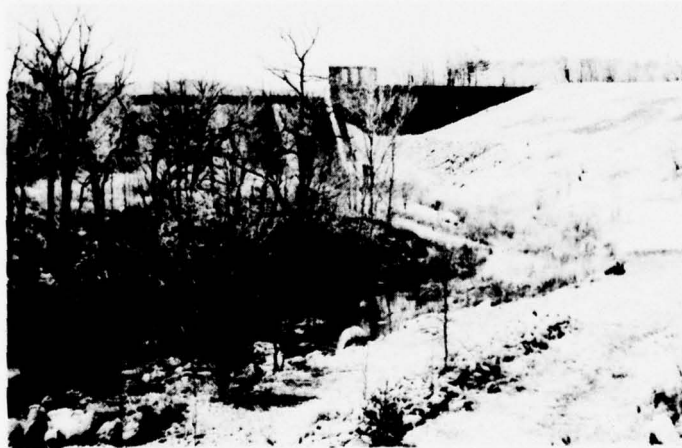
Photo 20 - View of downstream channel below dam; stony  
invert, well defined overbank valley

- (5) Repair automatic pool level recorder and restore plugged sump pump leading from cone valve pit in Intake and Gate House.
- (6) Initiate a program to control brush and tree growth in the channel area immediately downstream of the stilling basin.
